SIMULATION SOLVES THE MYSTERY BEHIND AN ELEVATOR ACCIDENT

While we can easily picture simulation as an integral part of product design related activities, other uses are equally important: Field failure analysis and forensic examination are two examples. Veryst Engineering used multiphysics simulation to investigate and determine how an elevator brake failed prematurely.

by STUART BROWN, NAGI ELABBASI, & MATTHEW HANCOCK, VERYST ENGINEERING

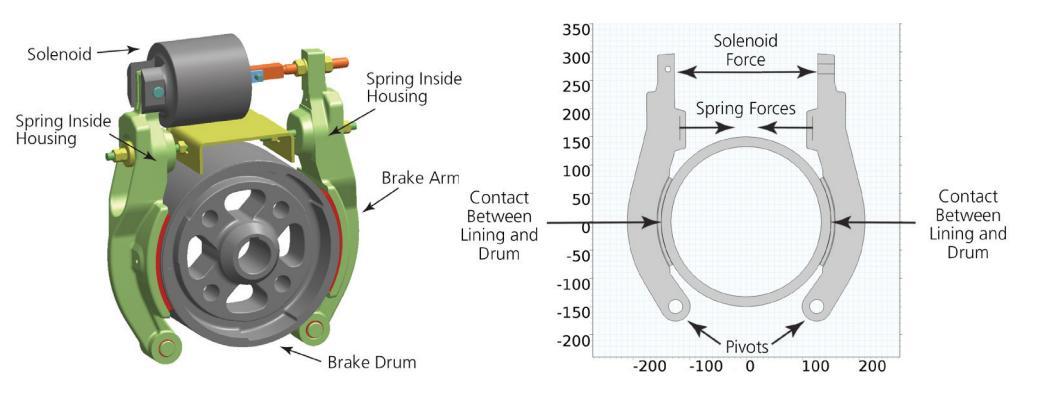
FIGURE 1. Left: Brake CAD geometry. Right: Brake lining wear model setup showing the brake drum, arms and pivots, the opposing spring and solenoid forces, and the contact between brake linings and the drum.

To test whether the extensive brake wear could have occurred swiftly given a damaged solenoid, we developed a COMSOL model of the brake to calculate the local brake lining wear. The model included the brake arm pivoting as well as the opposing forces of the springs and damaged solenoid. In addition, the model included data from the extensive wear experiments performed by investigators on prototype drum brake linings, which resulted in data correlating bulk lining wear rates to brake drum temperature.

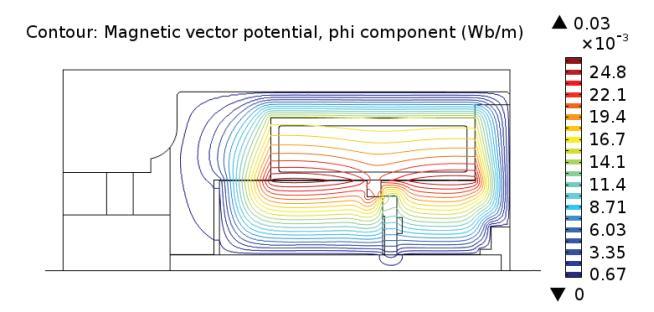
FIGURE 2. Magnetic potential within solenoid component.

A second theory for slow failure was that the EMF itself generated high stresses in the coil, causing it to fail over an extended period of time. We tested this by performing a coupled electromechanical analysis, which is shown in Figure 2. COMSOL® software was used to calculate the Lorentz force within the solenoid coil, demonstrating that the force throughout the coil was practically negligible.

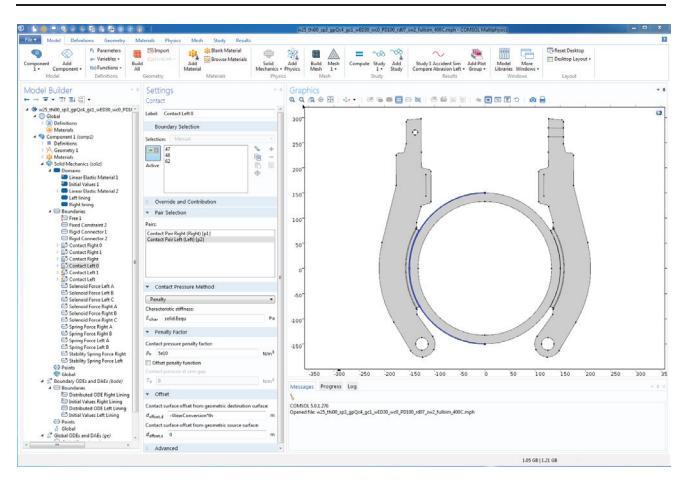
FIGURE 3. COMSOL Multiphysics[®] software model used to calculate brake lining wear.

Figure 3 shows the finite element model used in the wear analysis. Figure 4 shows a comparison between the measured and predicted brake lining wear along the length of the brakes at the end of the test. The model also predicted how wear depth varied with time. The results of the wear simulation indicated that a damaged solenoid could result in high drum temperatures, leading to rapid brake lining wear.

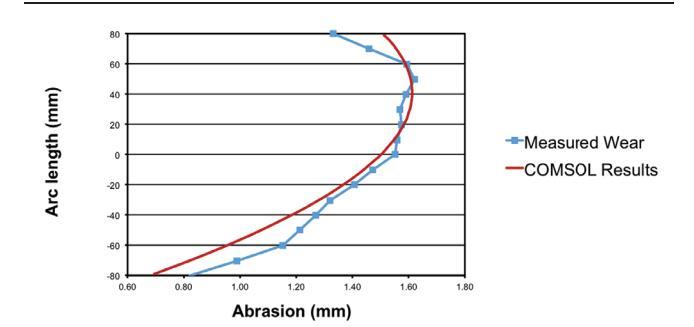
FIGURE 4. Comparison of measured lining wear with simulation prediction.
